OOAMA AIRMUNITIONS TEST REPORT

DISPOSAL TESTS

AIR-2A "GENIE" ROCKET MOTORS

DISPOSAL TESTS
FOR
AIR-2A "GENIE" ROCKET MOTORS

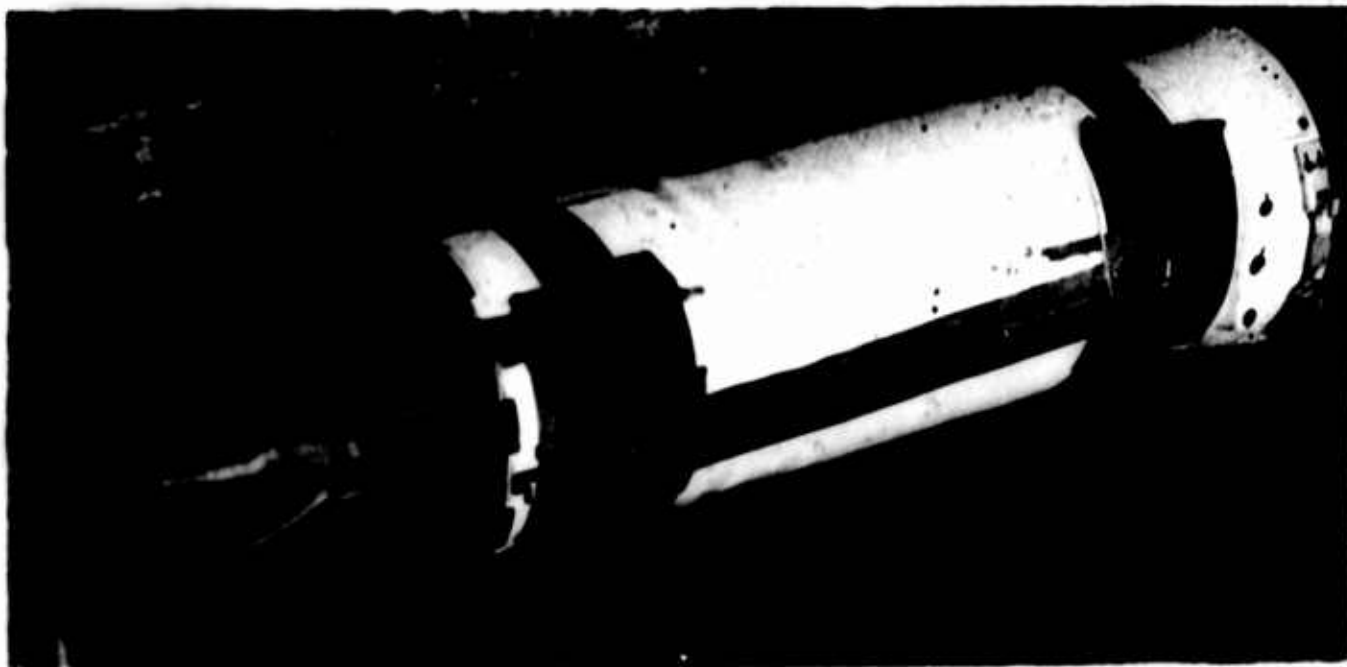
A large explosion followed by several smaller explosions occurred immediately after initiation of the flexible linear shaped charge (FLSC). The FLSC ignited the propellant and scattered it over a large area. Photo coverage showed the burning pieces were thrown 40-70 feet above the hole in which the motor was placed. The forward dome, which was severed from the motor case, was also ejected to a height of approximately 50 feet. Several pieces of unburned propellant, and a portion of FLSC were also found scattered throughout the area. The forward dome was located approximately 300 feet from the test site, the propellant was randomly dispersed up to approximately 300 feet from the test site and the FLSC was located approximately 5 feet from the hole in which the motor was placed. A post test examination of the rocket motor showed that the forward charge was the only charge to sever the motor case; the longitudinal FLSC charge, though detonated, did not split the case and the Aft FLSC charge failed to initiate and was ejected from the hole. (See Figures 8 through 11)

FIGURE 8: A PHOTOGRAPH OF THE FLEXIBLE LINEAR SHAPED CHARGE INSTALLATION FOR TEST 1.

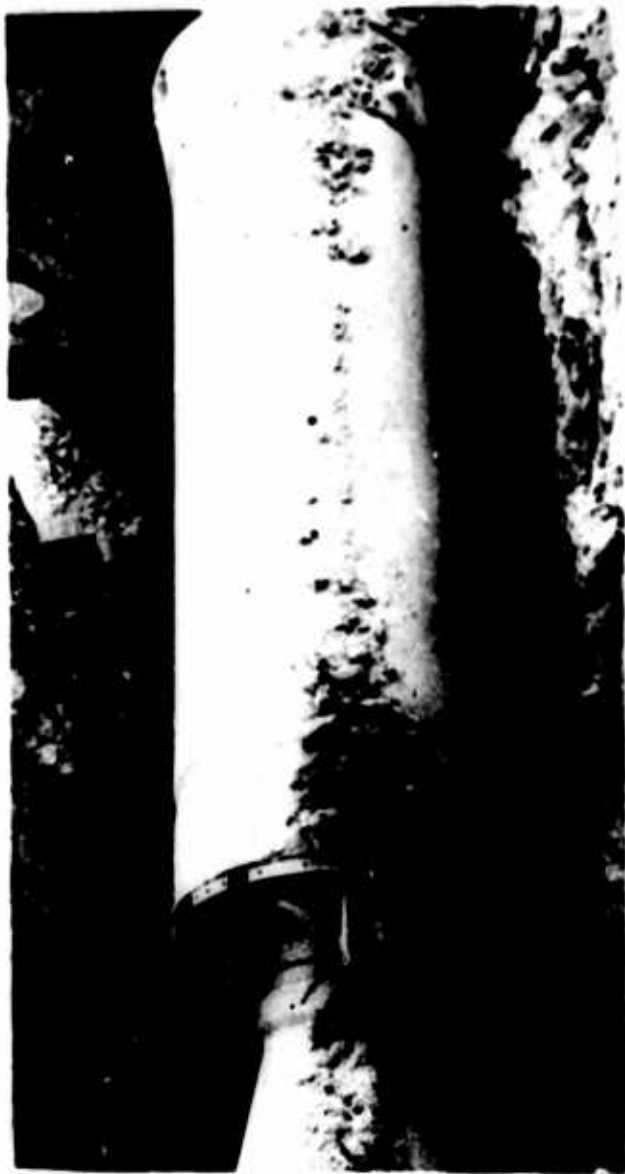
The detonating cord assembly, when initiated, caused only superficial damage to the rocket motor. It did not sever the aft end of the motor case or split it longitudinally as intended. The propellant also was not initiated by the explosion of the detonating cord. The rocket motor was indented along the aft end of the case and longitudinally to a depth of three-sixteenths inch by the blast from the detonating cord assembly. (See Figures 17 and 18)

FIGURE 17: THE REMAINS OF THE ROCKET MOTOR
AFTER INITIATION OF THE DETONATING
CORD. (TEST 4)

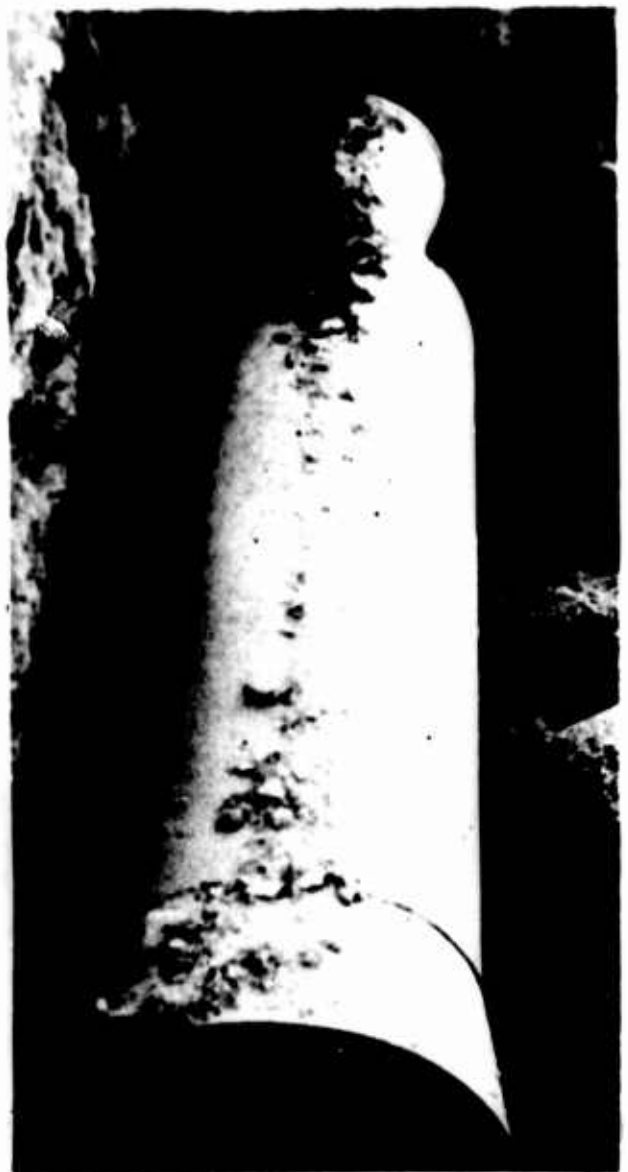
FIGURE 18: THE REMAINS OF THE ROCKET MOTOR
AFTER INITIATION OF THE DETONATING
CORD. (TEST 4)
